# LOW CARBON EXCHANGE

## External Walls, Ventilation Inspection Report & Recommendations for Oadby Wigston Borough Council

**Property Address,** Elizabeth Court, Wigston, Leicestershire, LE18 2AE

**Inspection Report:** Inspection of all external walls and all internal walls of a selected number of ground floor properties.

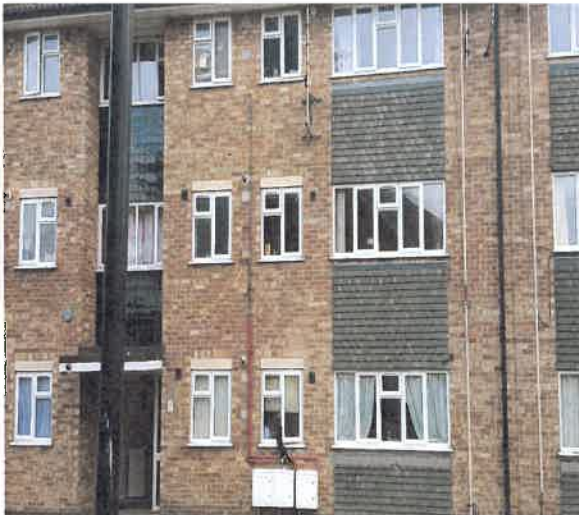
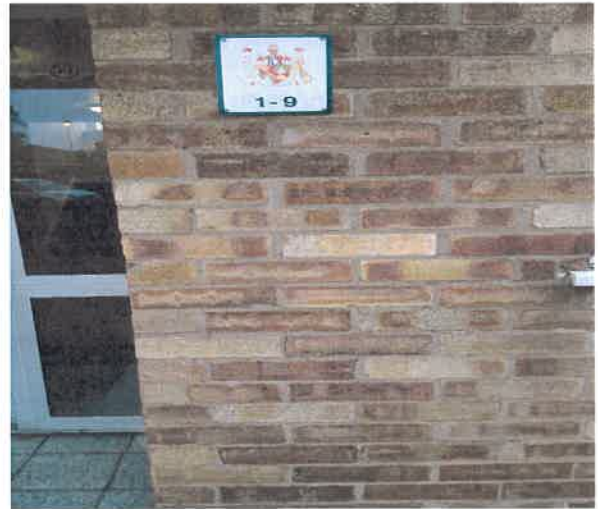
On visual inspection, the external walls are in good condition and show no signs of frost damage (spalling). The mortar between the external brickwork was found to be in a fairly healthy condition with 70% of walls of 80mm cavity construction and 30% hung tile solid wall construction, both of which have issues contributing to poor thermal performance of the overall building.

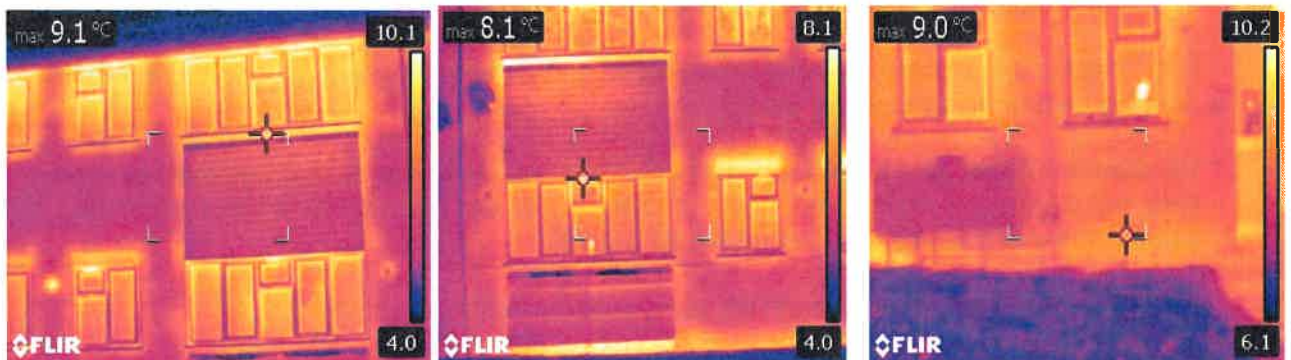
Upon inspection we found the hung tile areas, beneath window voids to be of solid block construction with no cavity. The thermal images below show the amount of heat loss from these areas, contributing to the poor thermal performance of the building. This combined with other building elements is giving rise to high humidity, excessive condensation and accelerated mould growth within the properties.

As an alternative, the inclusion of solid wall insulation to the existing solid wall infill areas will make a big difference to the control of moisture movement within the structures and should aid in the issues with mould growth around the windows. These areas immediately above and below the worst affected windows currently have no insulation.

This will improve the overall thermal performance of the building and in addition, the removal of the hung tiles, replaced with a proprietary insulated panel, will reduce the future cyclical maintenance and repair costs. Planning details will need to be considered.

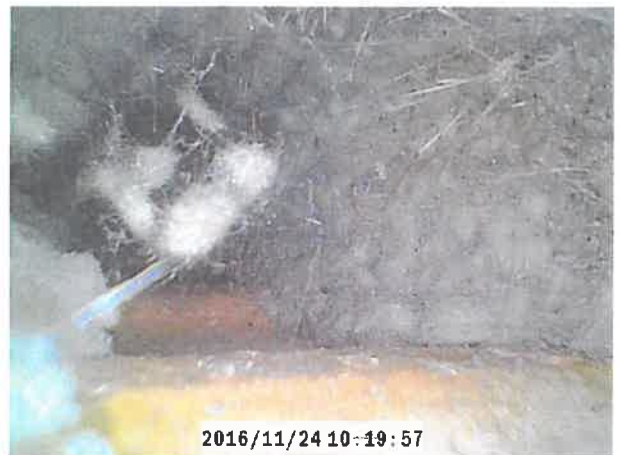
We drilled a number of Borescope inspection holes at different heights around the property, it was clear to see that the CWI was sparse with very low density and voids were being created leading to cold spots on internal walls.

2016/11/24 10:19:57  
Voids within cavity causing cold spots

We would recommend that the existing old fibre insulation be extracted utilising an accredited extraction process, LCX are accredited to Stroma Cavity Clearance Scheme (CCS). This should be allowed to dry out during spring/summer months and then re-filled with a high quality bonded bead solution.

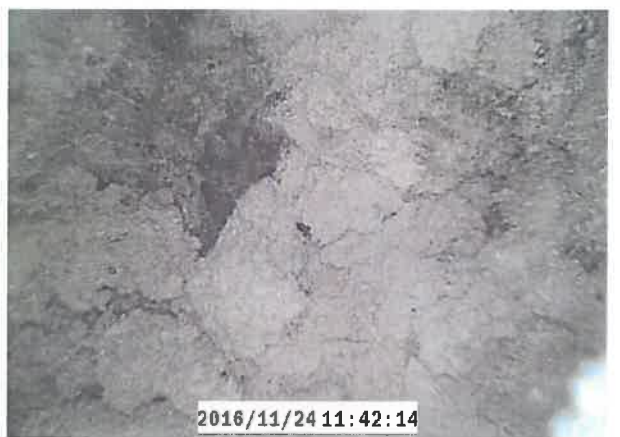
2016/11/24 11:42:14  
Debris within cavity

Remove any other loose debris from cavities likely to cause obstructions, providing an extract audit report. Replace the existing CWI with high performance bonded beads (Thermabead Carbon Saver) recommended.

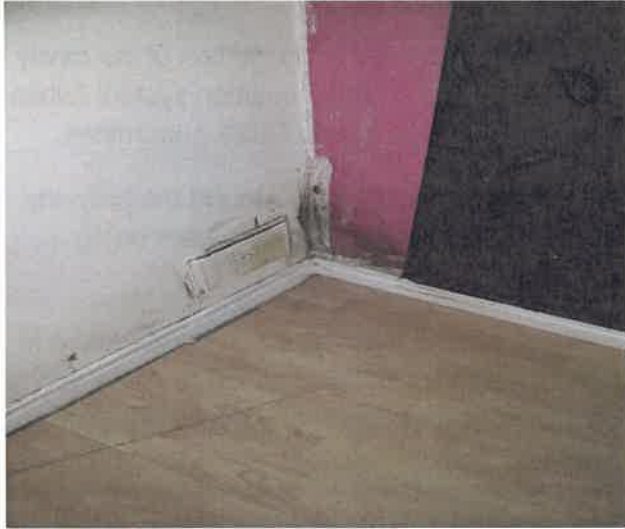
Airbricks installed

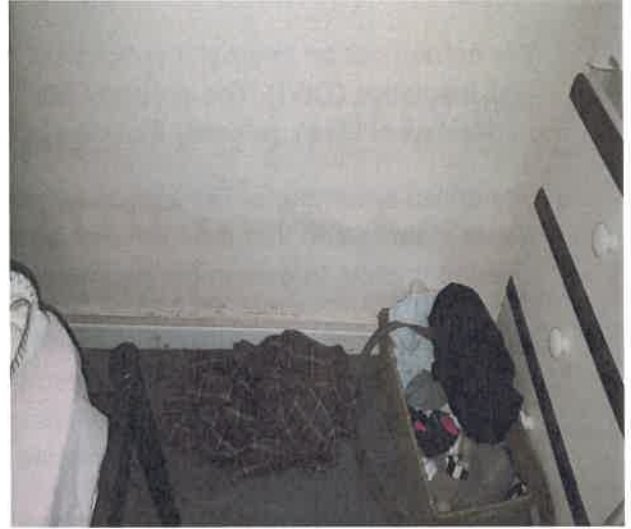
Moisture penetration of internal wall

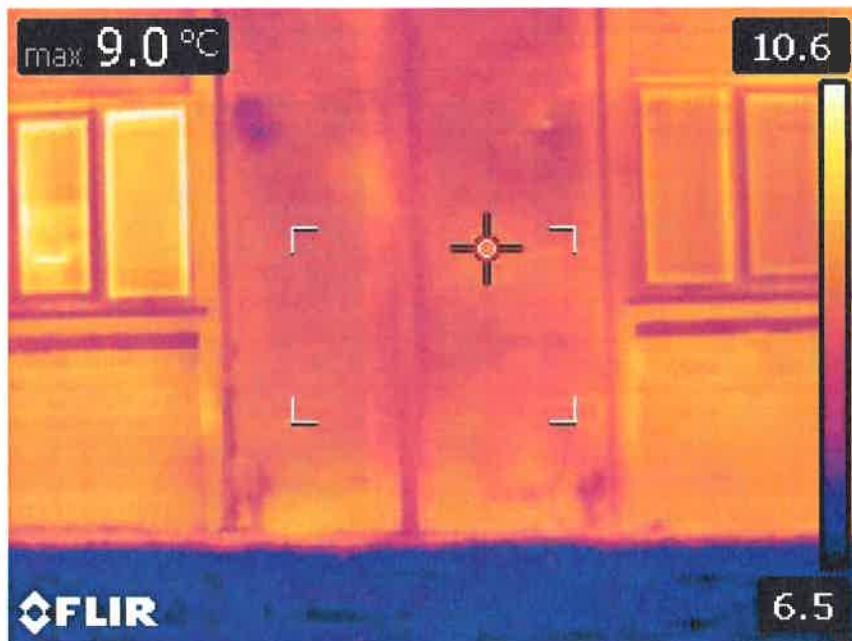
The construction of the fabric is unusual, in that the cavity wall is interspersed with a vertical band of solid wall strips, above and below the windows. The solid wall element makes up 30% of the overall building, the result of which is you have two completely different thermal efficient product types within the external wall elements, neither of which are currently effective.

The following thermal image highlights the heat loss at the junctions of cavity meeting solid wall and window reveals:

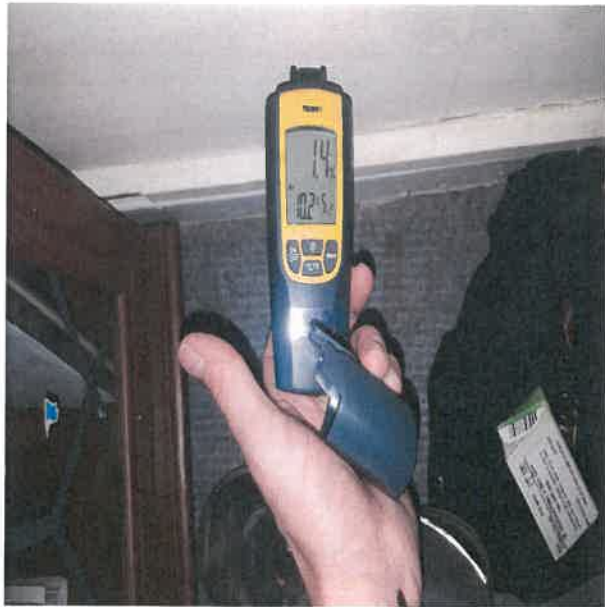
The low density of the fibre insulation within the cavity, causes voids and cold spots within the building structure, damp patches on the inside walls (external) and low thermal performance of the building, encouraging mould growth on internal walls, particularly at the elevation junctions.

High moisture content of internal walls

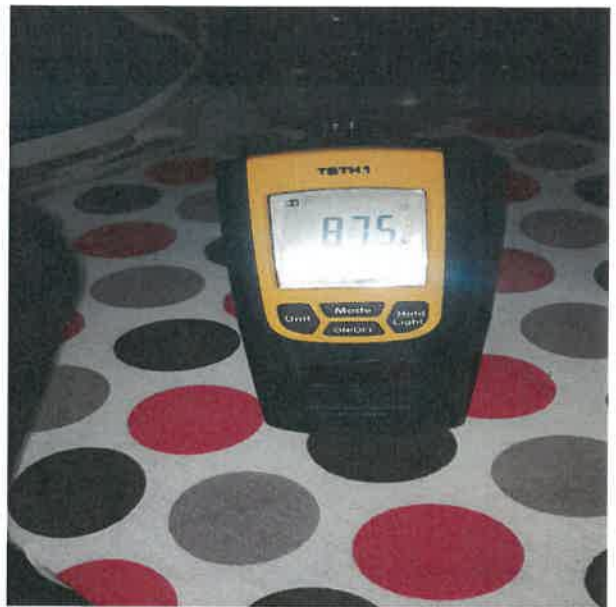
High Humidity Readings

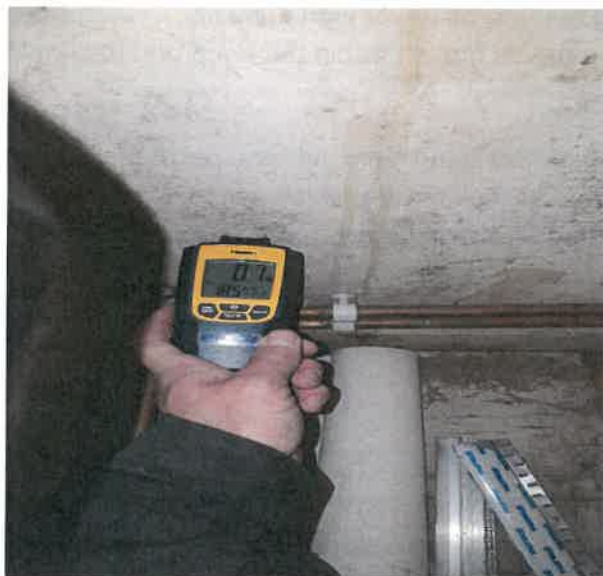
Accelerated mould growth high moisture

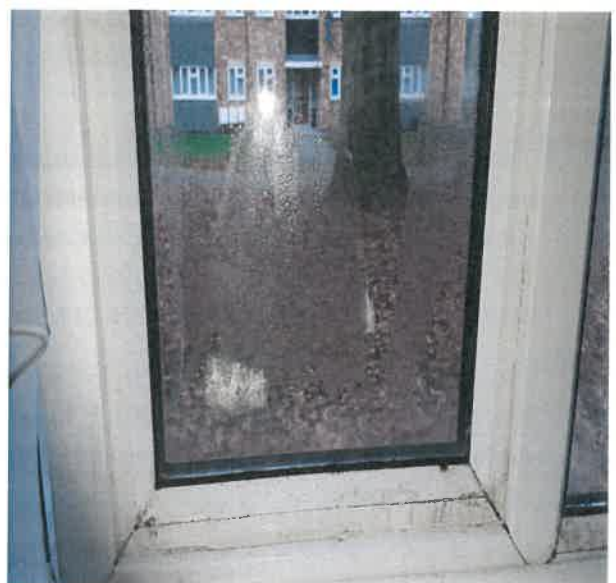
Excessive condensation on cold spots

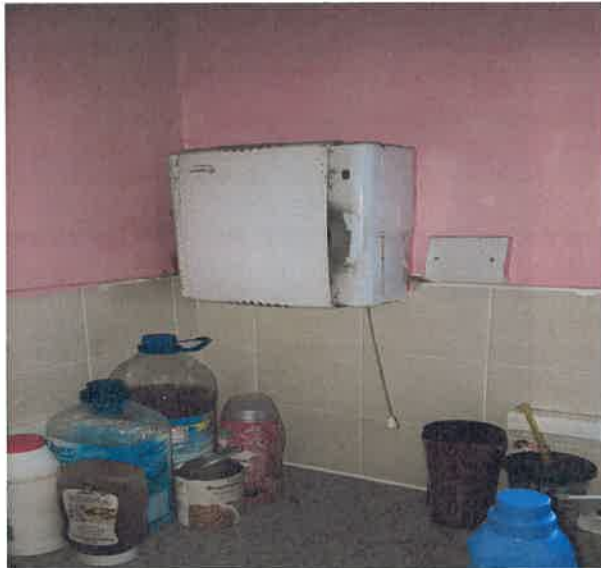
The ventilation within all properties visited, was found to be in a poor state of repair and inadequate for the existing building performance. The fans were old type axial fans, poorly sited, poorly serviced and maintained with cavity sleeves missing. Fan blades were blocked, fans were very noisy and energy inefficient and in some cases it would appear that tenants had turned them off, exacerbating the building condensation and mould growth problems.

Poorly sited, poorly maintained

Re-design and improve the ventilation with either Positive Input Ventilation (PIV) or Mechanical Ventilation Heat Recovery (MVHR)

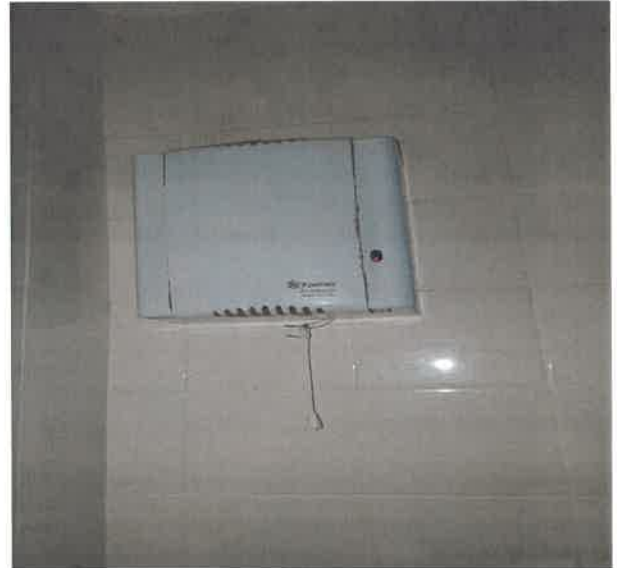
inadequate ventilation for building

The condition of the ventilation equipment within these buildings is insufficient to cater with the existing building performance and is adding to the problem of high humidity, increased/excessive condensation, encouraging mould growth within the living and habitable areas.

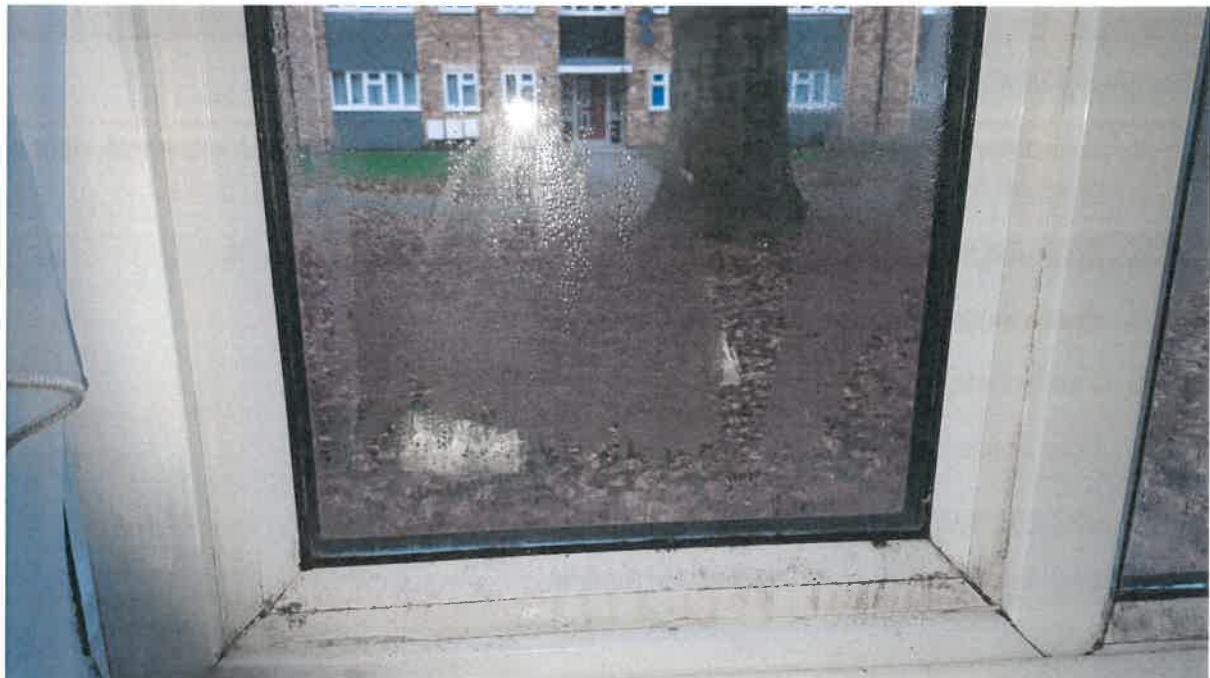
The existing windows are estimated to have been installed between 12-15 years ago, they are the older style double glazing, with 12mm glazing profile, poor or failing seals, cracked frames with the odd window sealed casement replaced in the larger units.

The cavity construction had a brick return at the windows, which are not thermally broken and leading mould problems at the window returns. The drop in temperature from the heated wall area to the window is causing high moisture content at the brick returns, rather than within the window zone, which is designed to accommodate the moisture build up (either by having surfaces that do not allow the water to be absorbed, or by having a purpose designed drainage systems).

The windows appeared to be of poor quality, with only a few having trickle vents, if it is within the clients budget, it would be advisable to replace these windows at the same time as the other recommended actions, to reduce costs on prelims such as scaffold and improve the overall thermal efficiency of the building and reduce future condensation and mould issues.

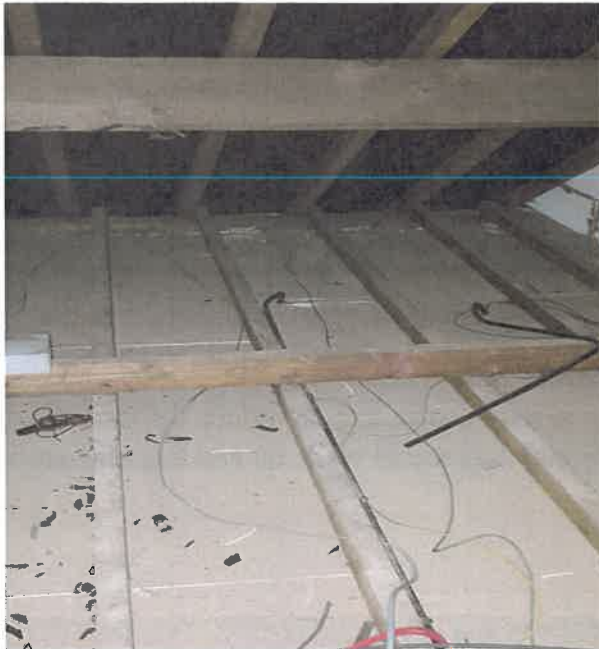
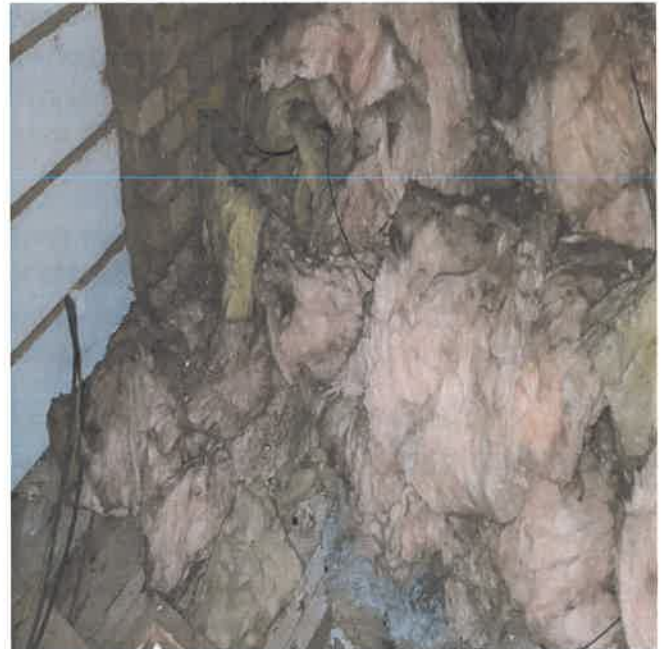
We managed to gain access to some of the loft areas above flats and within the communal areas. The communal areas were empty (no insulation) and we were able to observe poorly fitted insulation in 2 of the top floor flats, leading to cold bridging at the roof eaves, the following photographs depict the findings:

Remove existing loft insulation where installed, re-install loft insulation to all roof void areas
