Service Delivery Committee	Tuesday, 22 March 2016	Matter for Information and Decision
---------------------------------------	-----------------------------------	--

Title: **Bell Street, Wigston - Update on Prohibition of Vehicular Access**

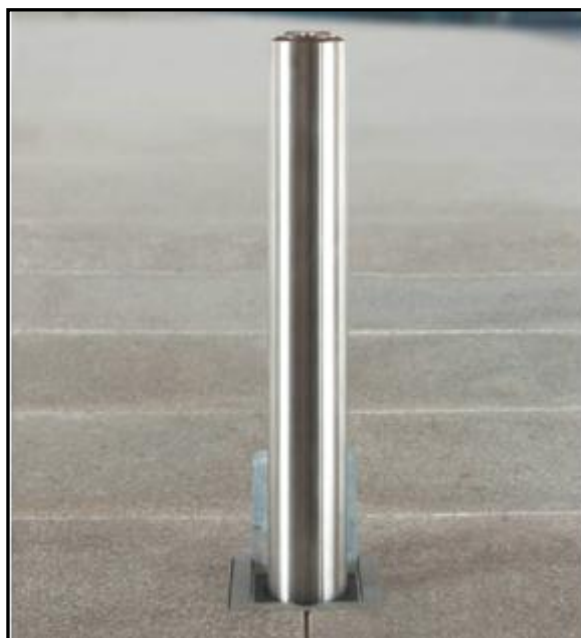
4. 'Like For Like' Replacement Bollard

- 4.1 This bollard is relatively easy to use, we already have the keys cut for this system and have supplied these keys to the emergency services. The bollard also allows the general public to walk through easily without a blockage. A system such as this is ideal as the bollard does not need to be removed very often.
- 4.2 This bollard also ties in with the look and feel of the new public realm within Bell Street. There is minimal maintenance on this style of bollard, so ongoing costs are reduced.
- 4.3 The disadvantage with this bollard is that if a vehicle hits the bollard at speed, it requires a complete replacement of the bollard and it's underground socket.
- 4.4 The indicative cost for purchasing one of these bollards is £390 and the installation is up to £400, therefore a replacement cost is £790 every time it is seriously damaged.

- 2.1** It is recommended that a like for like telescopic bollard remains the method used to prevent unauthorised vehicular access into Bell Street, due to the ease of use, matching design with the Bell Street public realm and relatively low costs to maintain and manage.

- 8.1 From these 4 options it is proposed that the current style of bollard is maintained as this offers good value for money and an attractive design. It also offers an easy to use system that is already in place.
- 8.2 A review of the operation of the bollard will take place within the next six months, whereby if further damage is taking place to the bollard we can revisit these options or explore other methods of barrier.

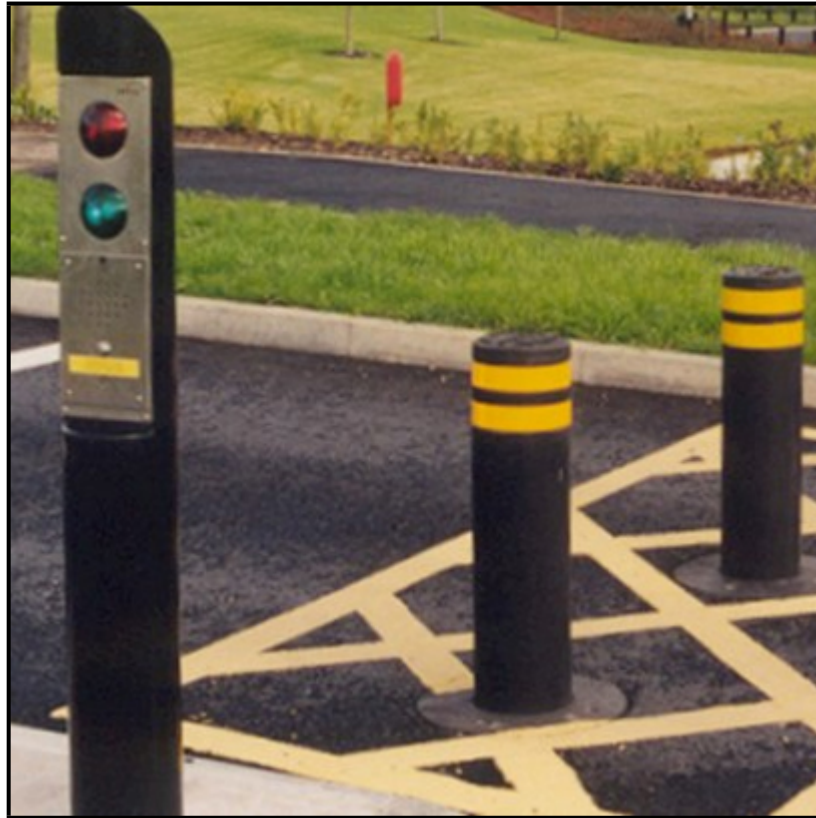
5. Automatic Rising Bollard

- 5.1 An automatic bollard would allow easy access to Bell Street at all times and would not require keys to operate. There would either be a key code system or a card access system. These bollards are extremely robust and if they were hit by a vehicle, they would still be able to operate.

- 5.2 These bollards have some very sophisticated electronics, enabling it to detect when a vehicle is in range and lowering when a code/card is entered. The bollards would then lower for the vehicle, and detect when the vehicle has passed and then raise. This means only one vehicle at a time is allowed and they are usually programmed to lower automatically when leaving the area.

- 5.3 The disadvantages with this type of bollard are that there is not the need to access Bell Street on multiple occasions through a day as it is currently pedestrianised, which is the main advantage of this system. Also the bollard needs regular servicing (approx £300 per visit) and cards would have to be allocated to people who are allowed to

access (cost of £20 per card). This would then need to be monitored and an officer made responsible for issuing cards and managing the bollards.

- 5.4 They are also very expensive to install, with a minimum cost of around £20,000. There would also be a lot of disruption to install these bollards.

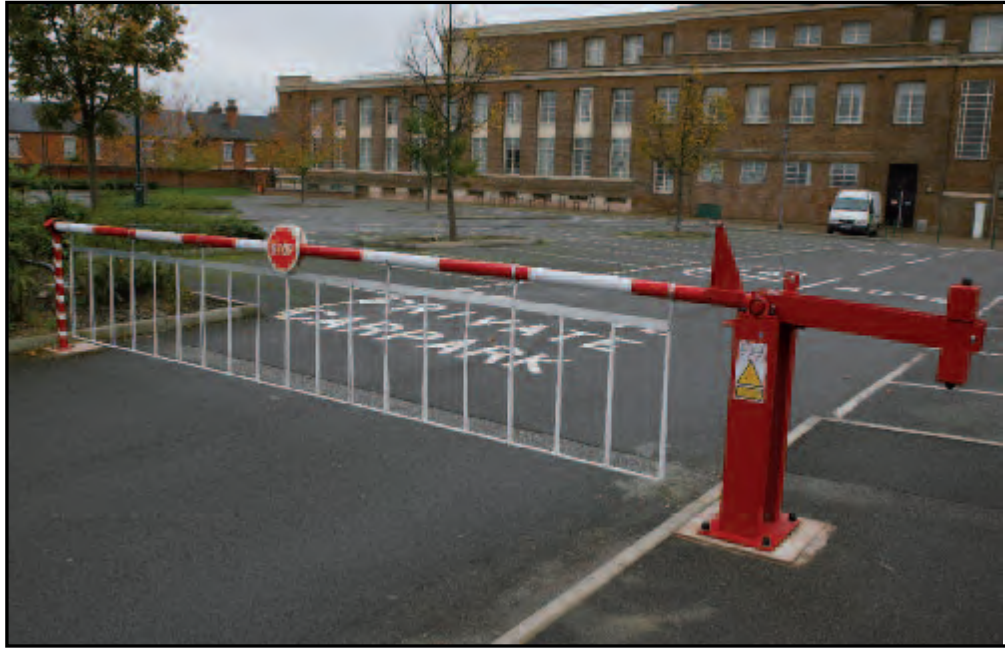
6. Rising Barrier

- 6.1 These barriers are very effective in preventing access, as well as being very visible. Also if a vehicle does hit this style of barrier, it should be relatively cheap to repair, as it is bolted to the ground (rather than rooted into the ground).
- 6.2 The disadvantage with this style of barrier is that it would stop pedestrians being able to walk freely into Bell Street. Although very visible, it would also detract from the look of the new public realm in Bell Street. Also a lifting barrier could be a safety risk to the public when people are accessing the barrier, due to the nature of a bar being lifted and lowered.
- 6.3 A barrier like this would cost approximately £800 to purchase and approx £1,200 to install. The ongoing maintenance of this would come in at around £200 per year.

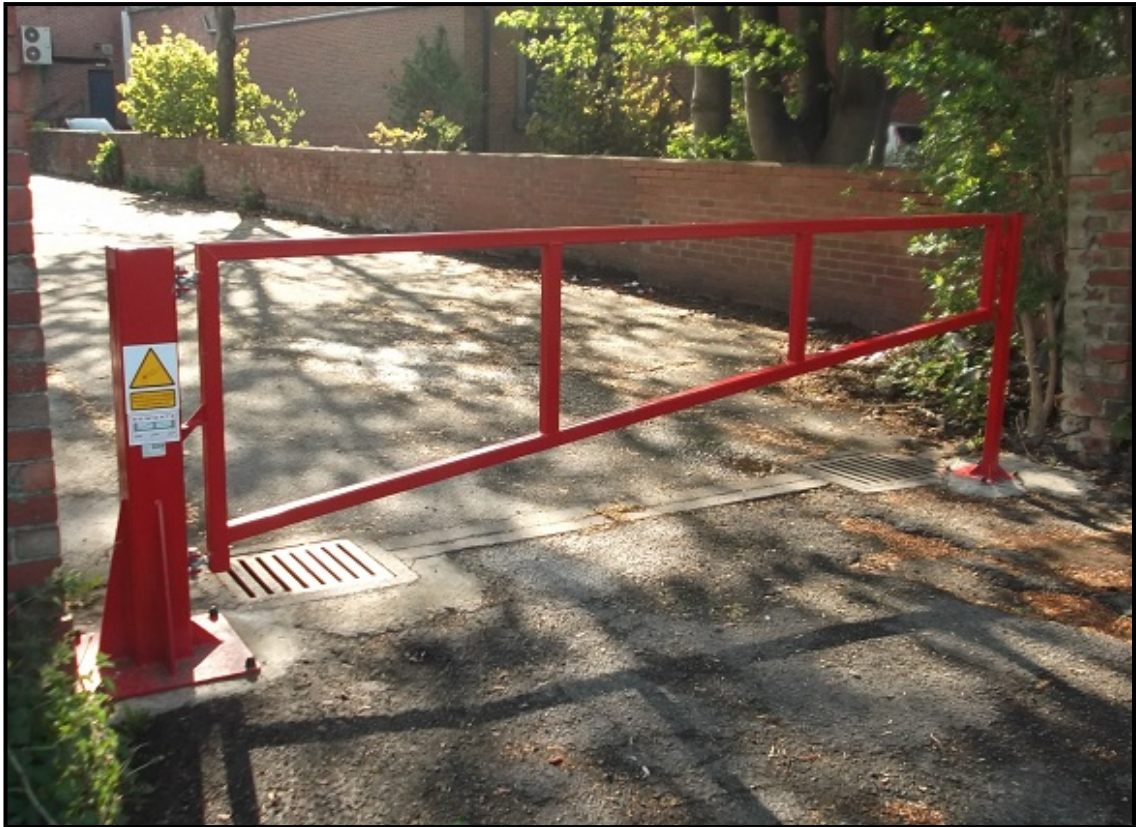
7. Gate

- 7.1 A Gate would be very similar to the rising barrier and are very effective in preventing access, as well as being very visible. Also if a vehicle does hit this style of barrier, it should be relatively cheap to repair, as it is bolted to the ground (rather than rooted into the ground).
- 7.2 The disadvantage with this style of barrier is that it would stop pedestrians being able to walk freely into Bell Street. Although very visible, it would also detract from the look of the new public realm in Bell Street
- 7.3 A barrier like this would cost approximately £700 to purchase and approx £1,200 to install. The ongoing maintenance of this would come in at around £200 per year.
